IBM Office Products Division Customer Engineering • "IBM", "Executive", IBM "EXECUTARY" and "Selectric" are registered trademarks of the International Business Machines Corp.

F/N 241-5501-4

AUGUST, 1976

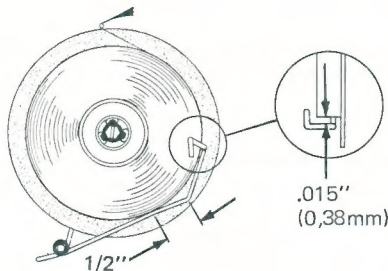
Feed Erratic

If you find erratic ribbon feed occurring only when a new spool is installed, the following fix may be quite useful. Using the 3-prong pliers, form the follower wire so that with a full supply spool, the normal contact area of the wire will clear the spool by approximately .015" (see illustration).

When the spool is full, only this form angle will touch. As the ribbon is used, the follower will move back to a normal contact action.

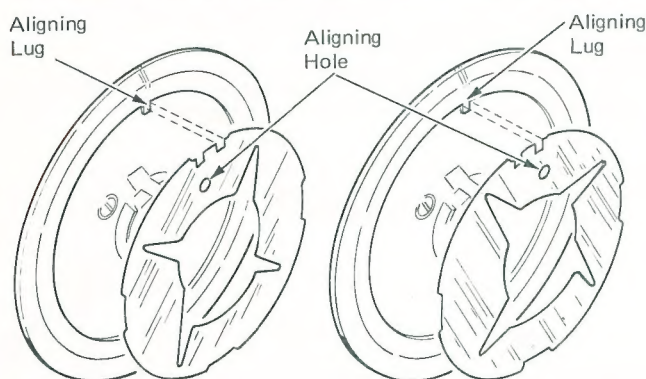
Old Style New Style

The carbon ribbon inner flange was modified to ensure stability at about the time the Model "D" was announced. The old flange can be used on late level take-up assemblies, but the new flange due to the extrusion can be used ONLY on the late level.

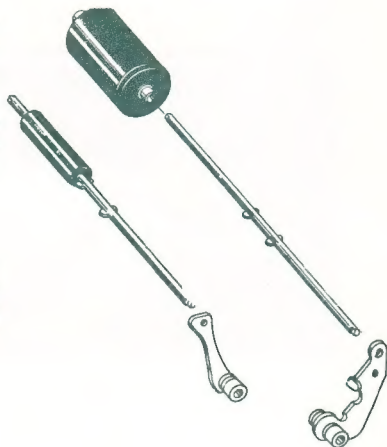
— **Model D:** The new-style feed roll shaft is not compatible with the old-style feed roll levers on Model C's or Model D's below S/N 6198123 Standard and S/N 8328277 "Executive" Typewriters.

The new-style feed roll shaft can be installed on these machines by installing the new-style feed roll levers.

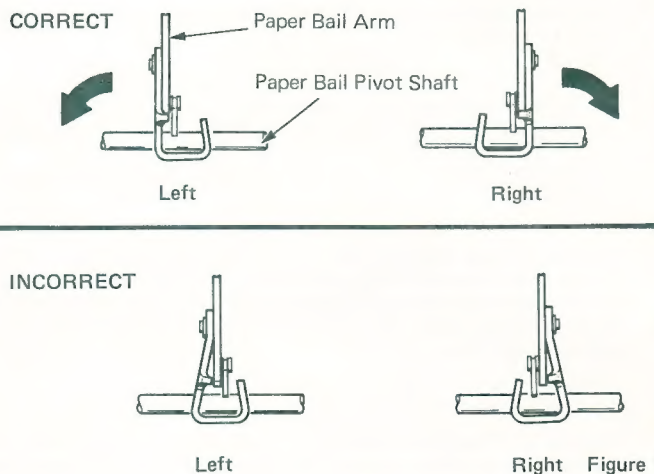
Figure 1

Paper Bail — Loose — Model D: If experiencing problems with paper bail arms (02-312, 313) camming over stops on paper bail pivot shaft, form the pivot shaft arms as shown below.

Note: If the arms still cam over pivot shaft stops, remove bail arm C-clips (02-12) and replace with grip clip, P/N 528552. This part is in parts packet No. 3.

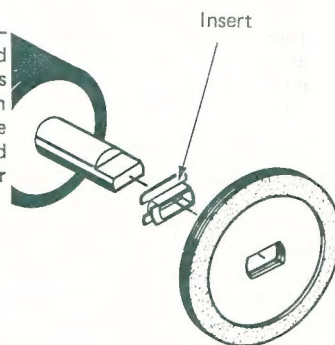
Clutch Disc — Removal

The following method is offered for easier removal of the C/R clutch disc on modified carbon ribbon equipped machines:

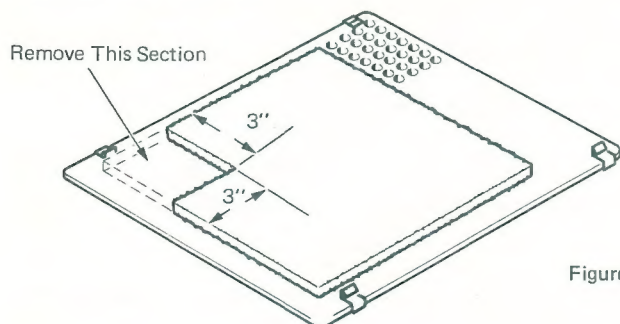
Figure 1

5. Sound deadening material on bottom panel may contact the interposer links. If this happens, remove sound material ONLY in the area of the links (Fig. 1). New bottom panels have material removed in the link area.

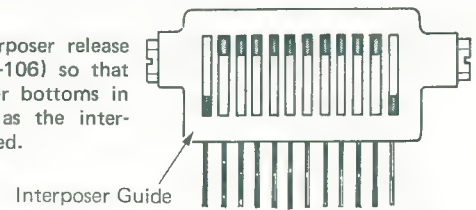
Interposer Remains Up Occasionally an interposer may remain up after contacting a set tab stop. This happens only when the operator holds the keybutton down while the tab is being unlatched. To correct this condition, form the lug on the bail arm for .000" clearance instead of .005"-.010". This allows the restoring bail to contact a greater portion of the interposer link lug.

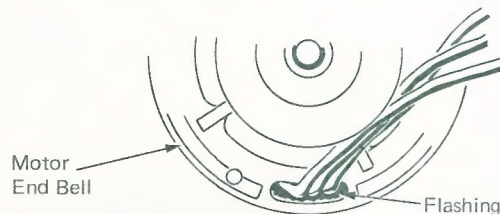
There is a potential safety hazard with the motor ground wire screw. A longer screw was substituted during manufacture of some machines and **MUST** be replaced. Some motors may have been installed so that the tip of this screw can contact the motor winding. Replace the screw with screw, P/N 738378 and washer, P/N 56079.
